# National Transportation Safety Board Aviation Accident Final Report

<b>Location:</b>	McFarland, California	<b>Accident Number:</b>	WPR16FA037
<b>Date &amp; Time:</b>	December 10, 2015, 19:03 Local	<b>Registration:</b>	N408FC
<b>Aircraft:</b>	Bell 407	<b>Aircraft Damage:</b>	Destroyed
<b>Defining Event:</b>	Loss of control in flight	<b>Injuries:</b>	4 Fatal
<b>Flight Conducted Under:</b>	Part 135: Air taxi & commuter - Non-scheduled - Air Medical (Discretionary)

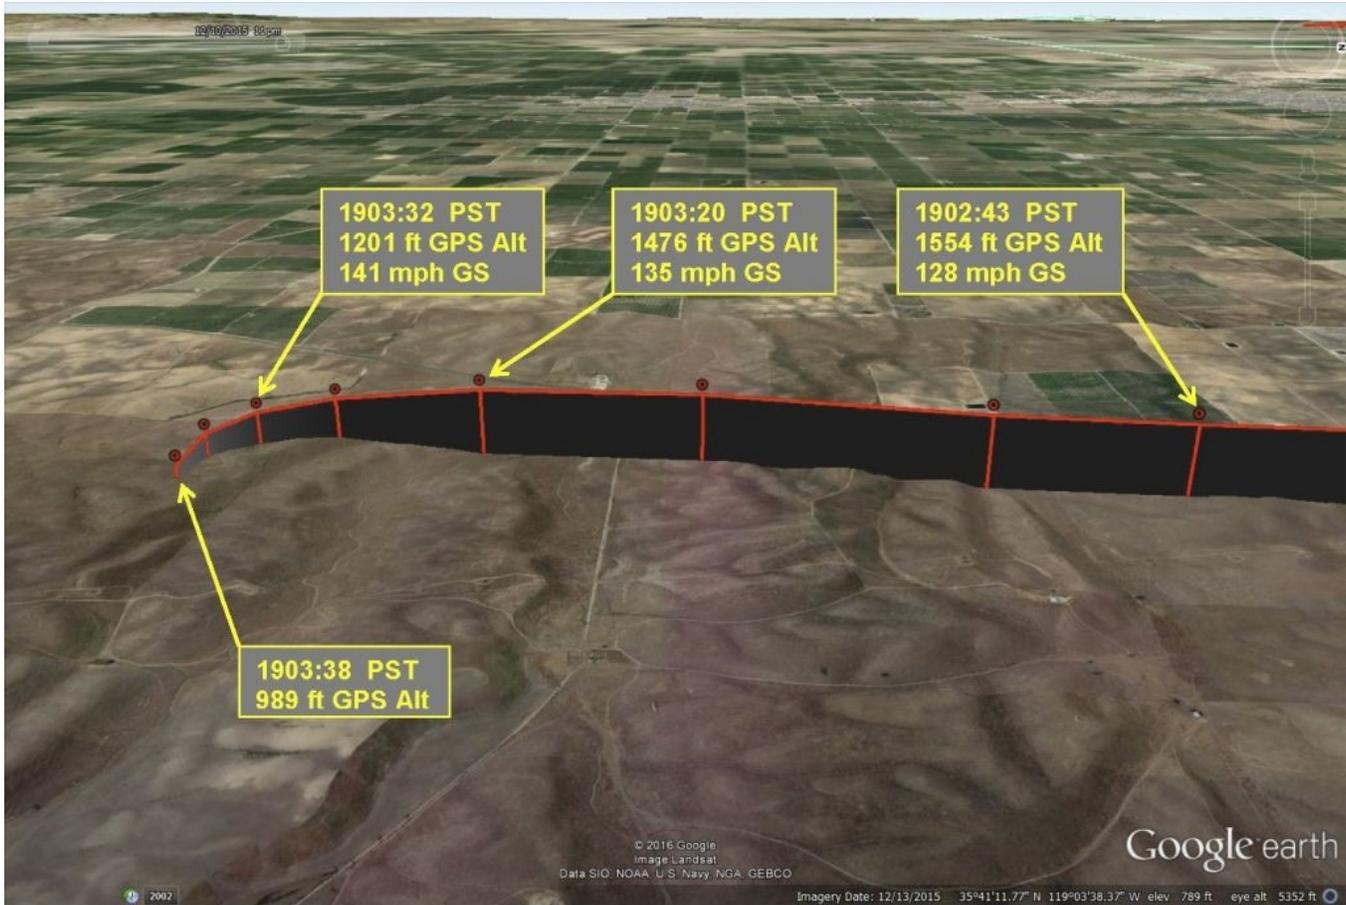
Between 1903:08 and 1903:20, the helicopter's GPS altitude decreased from 1,535 to 1,476 ft, and the groundspeed increased from 135 to 138 mph, while the helicopter flew along a magnetic heading of 185°. At 1903:28, the helicopter began a left turn while descending through 1,300 ft at a groundspeed of 141 mph. The last three recorded data points—at 1903:32, 1903:35, and 1903:38—showed that the helicopter continued to descend; the GPS did not indicate a groundspeed for the last data point, which was recorded when the helicopter was about 590 ft southwest of the accident site. The calculated rate of descent for the last three data points was 2,210 ft per minute. Figure 1 shows the GPS-derived data points between 1902:43 and 1903:38.

Figure 1. Final eight GPS-recorded data points.

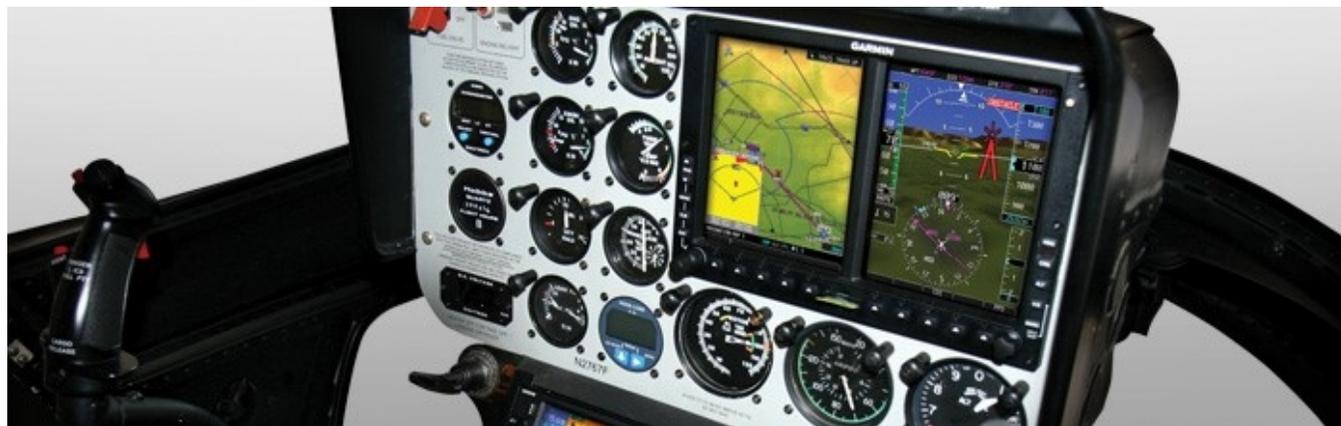
Figure 2. Garmin G500H system similar to that installed in N408FC (the accident helicopter) , Obtained from Garmin.Com.

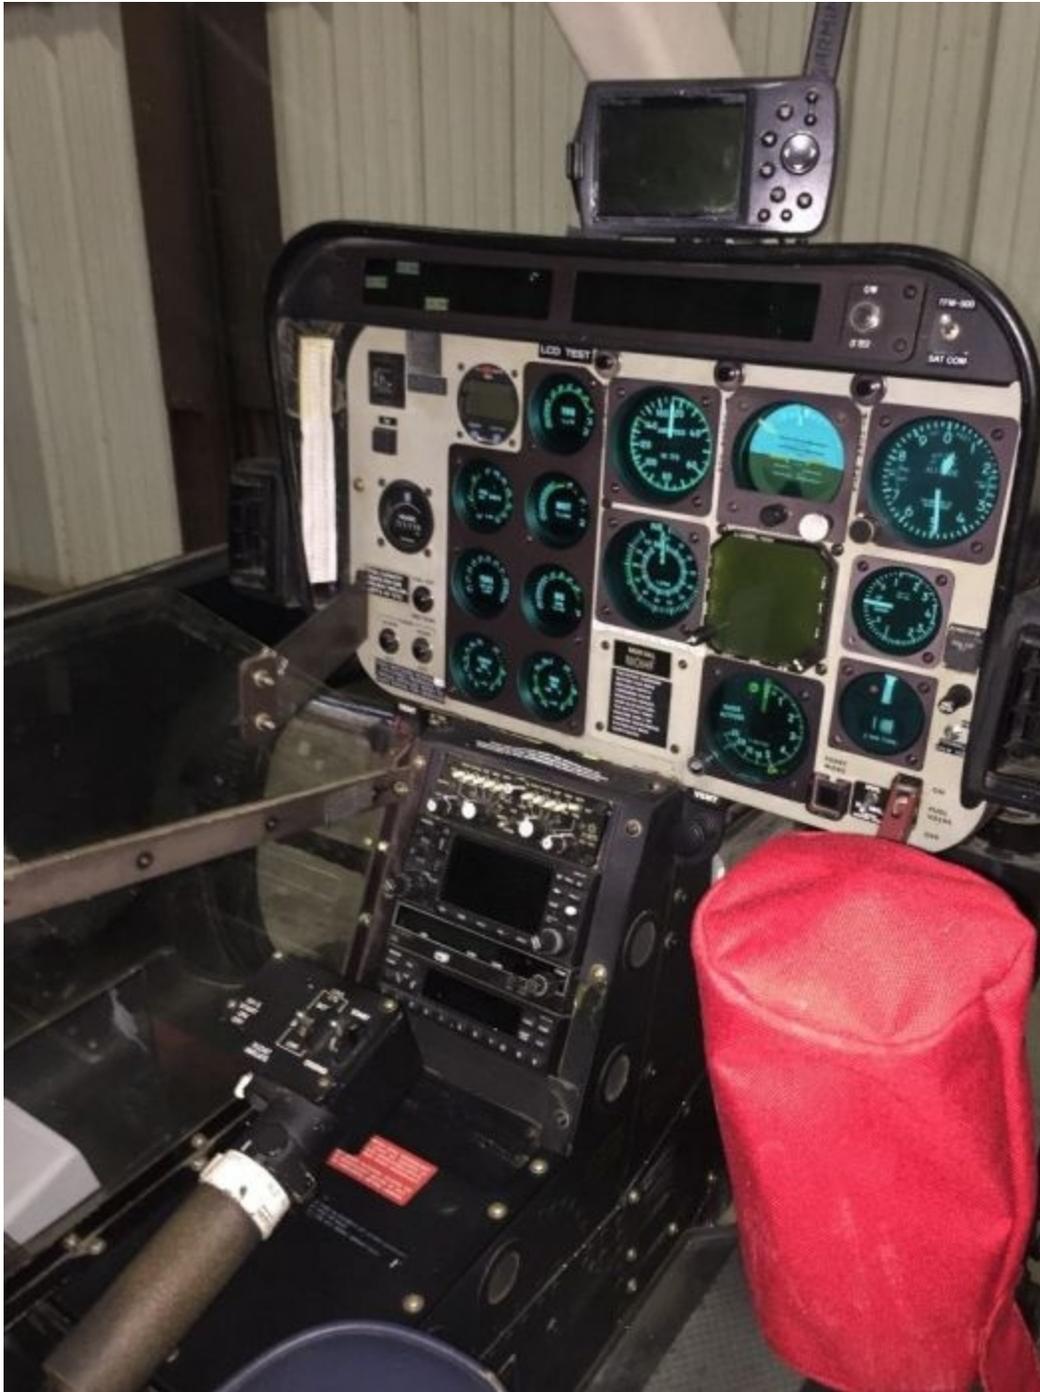
The pilot primarily flew another company Bell 407 helicopter, N101HF, that was also configured for HAA operations. As shown in figure 3, this helicopter had analog instruments and not the advanced avionics installed in the accident helicopter.

Figure 3. Analog instruments installed in N101HF.

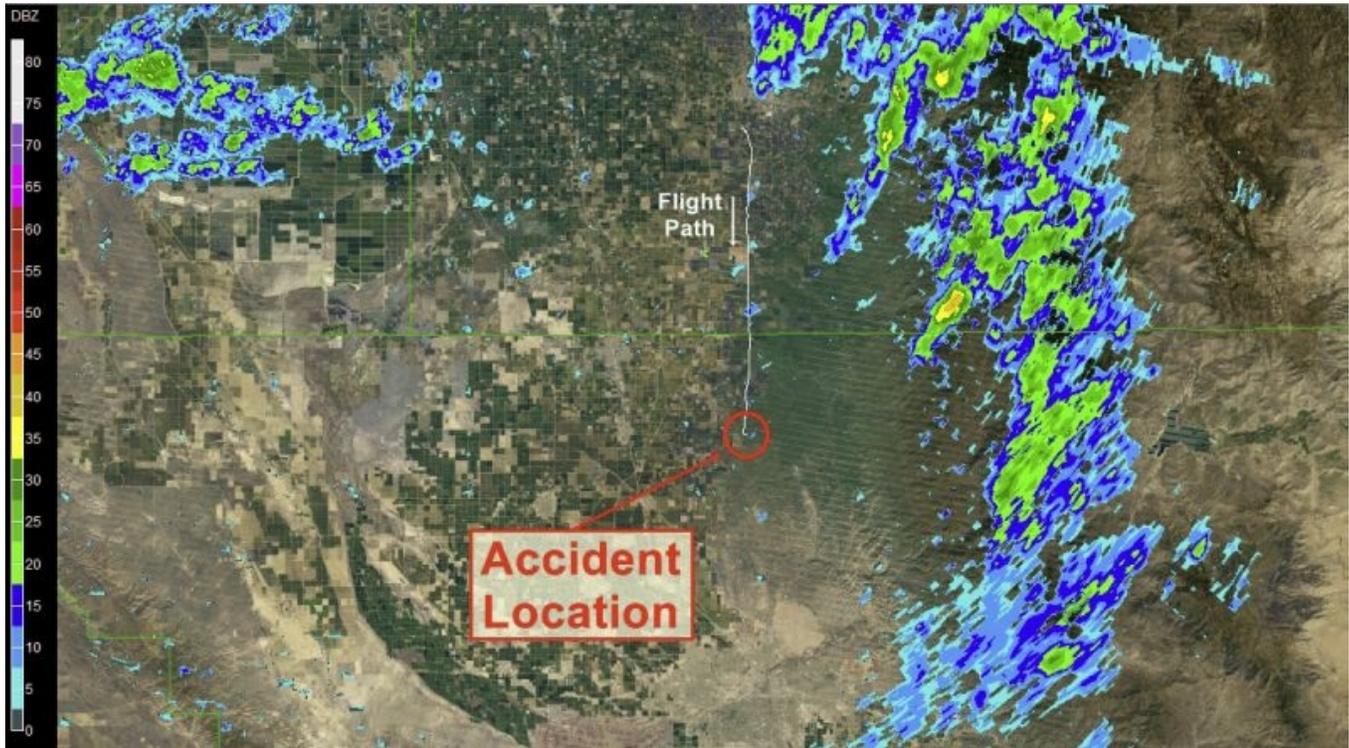
The closest National Weather Service Weather (NWS) Surveillance Radar-1988, Doppler (WSR-88D) was located in the San Joaquin Valley, California, about 47 nm northwest of the accident site. The WSR-88D captured base reflectivity imagery at 1902, as shown in figure 4, which mainly depicted light to moderate values of reflectivity to the east, northeast, north, and northwest of the accident site.

Figure 4. WSR-88D base reflectivity imagery.
