National Transportation Safety Board Aviation Accident Final Report

Location:	Brainerd, Minnesota	Accident Number:	CEN19FA185
Date & Time:	June 28, 2019, 00:40 Local	Registration:	N11NM
Aircraft:	Agusta A109	Aircraft Damage:	Substantial
Defining Event:	Loss of control in flight	Injuries:	2 Fatal, 1 Serious
Flight Conducted Under:	Part 135: Air taxi & commuter - Non-scheduled - Air Medical (Discretionary)

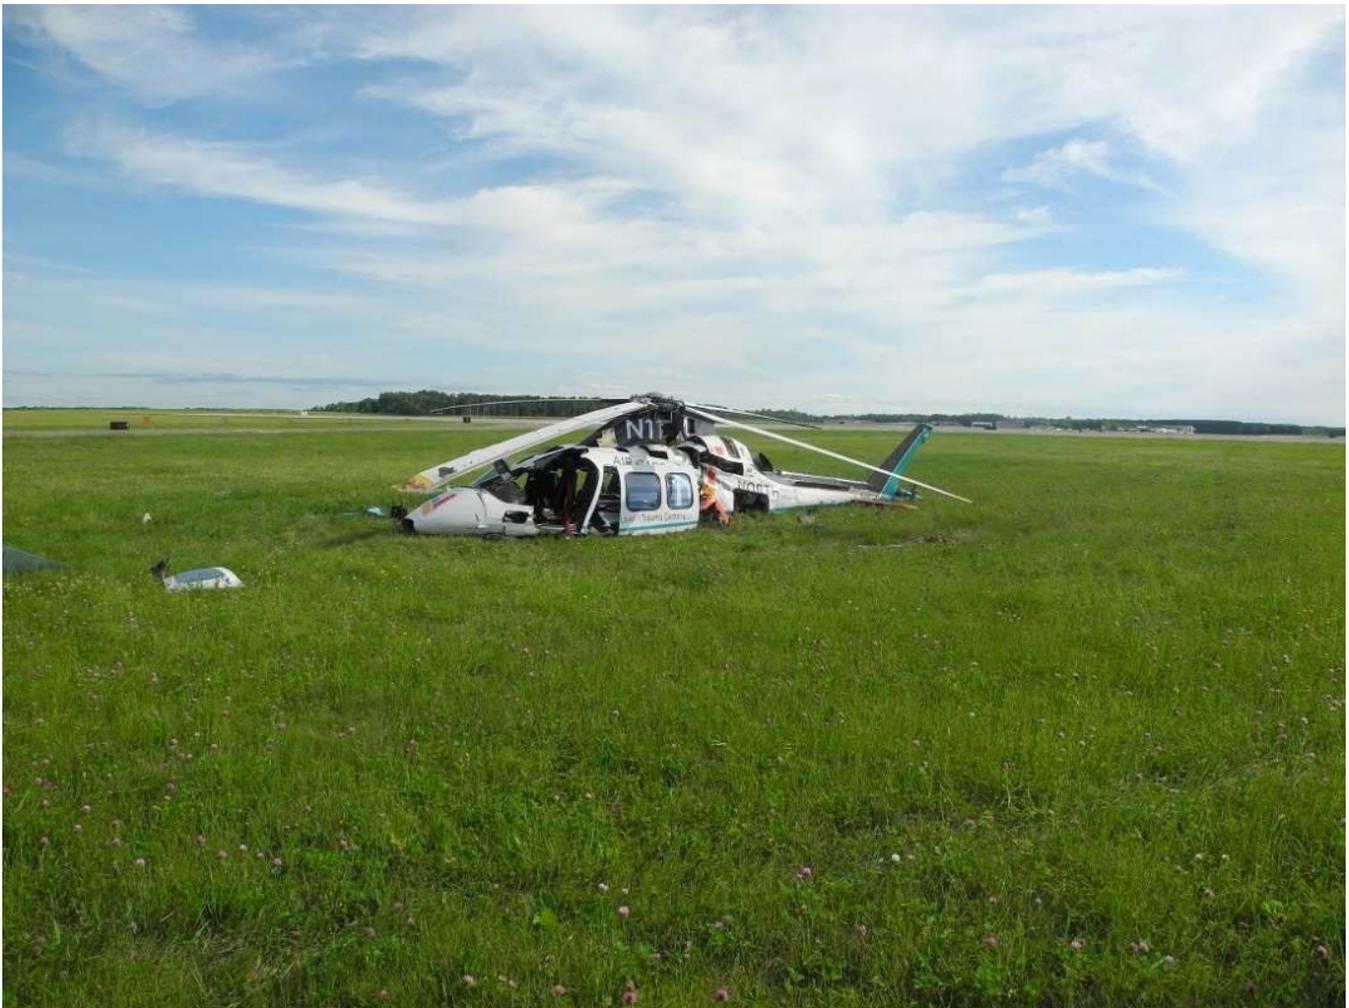
Figure 1. View of Helicopter at Accident Site

The helicopter impacted a grassy area south of runway 23 and came to rest upright and nearly intact on a heading of 074°. The main fuselage and tail boom exhibited crushing consistent with a high-velocity vertical descent and impact. (See Figure 1.) The helicopter was upright and nearly intact, with no movement from the initial impact point. There was no evidence of a postcrash fire. The ground adjacent to the wreckage was soaked with fuel and the smell of fuel was present at the accident site.

Examination of the helicopter and review of recorded flight information revealed no evidence of mechanical malfunctions or failures that would have precluded normal operation.
